## **Project Update: May 2014**

The hurricane season for the eastern Pacific region has commenced. The first Hurricane of the season has been named Amanda. The first week in May 2014, we began monitoring beach morphology in a new area of coastal development within our study area.

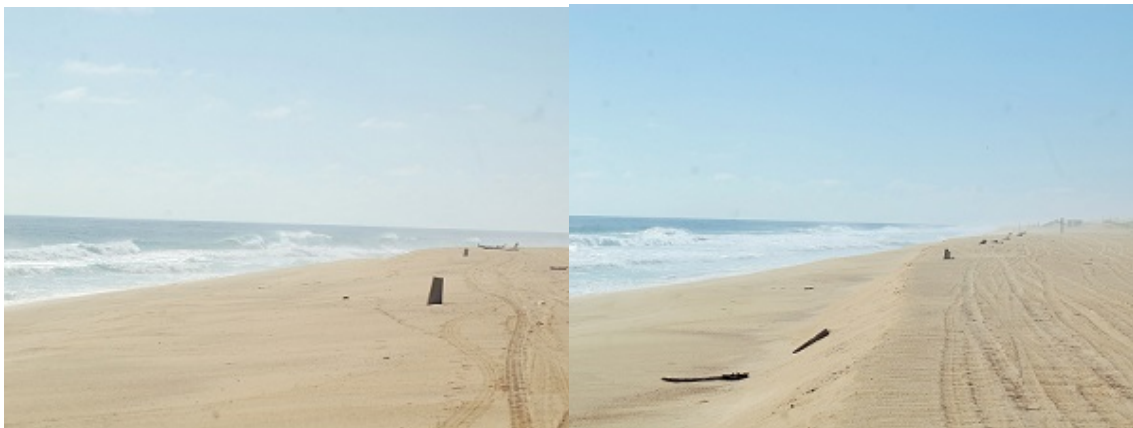
In the attached photos, the concrete pilings represent the limits of construction. Photo 1 shows the beach with a gradual slope at high tide during a new moon. Photo 2 shows the beach with slight natural erosion occurring at high tide just before a full moon. Photo 1 was at a time when the tides ranged only 6 m. Photo 2 is during a lunar cycle where the tidal flux maximum is on average 20 m. One can see the severity of what will happen during a storm event when the tidal flux is over 40 m during a new moon cycle and over 60 m when tidal flux can reach 60 m.

Our research that was funded from Rufford and these photo documentations reveal to us that the federal maritime zone of 20 m, which is used to delineate construction limits, is not sufficient for this area. Thus poor regulation not only leads to lack of natural protection from storm surge, but also permanently removes critical nesting habitat for endangered sea turtles. Thanks to this funding, we are able to present the Mexican government with scientifically - sound, statically reasons why they should expand the federal maritime zone to a minimum of 60 m in nesting habitat.
