Extension of community based mangrove restoration model focusing on fallow shrimp-farming ponds in Cam Ranh, Khanh Hoa

ABSTRACT

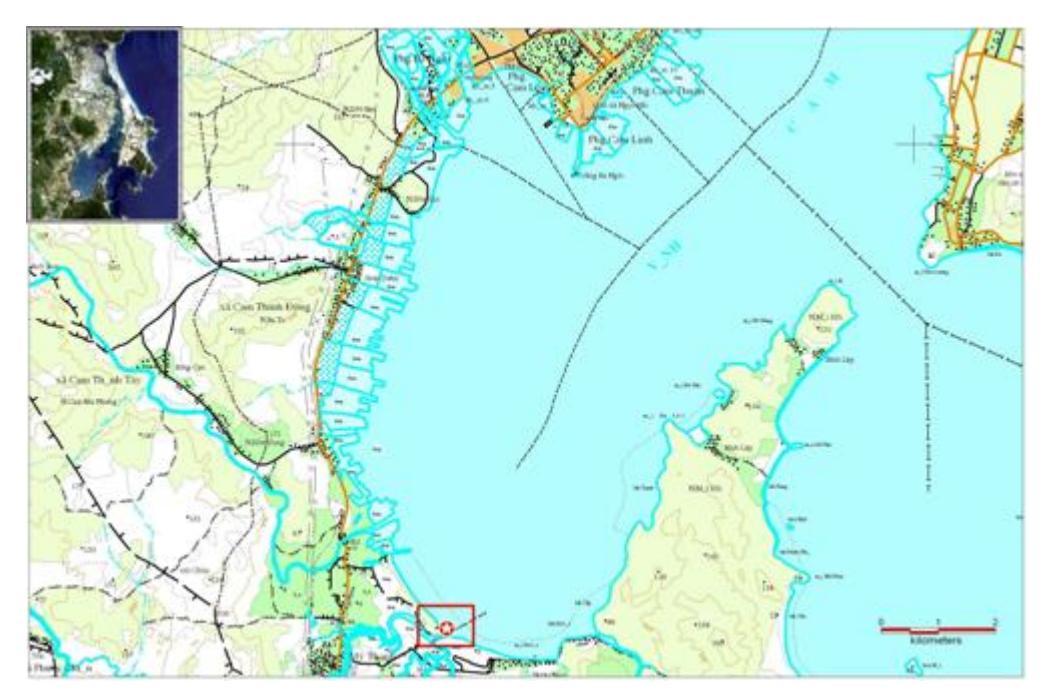
- Area 1 (1ha): strongly affected by wave and flood
- Area 2 (3ha): strongly affected by waves and flood during raining season
- Area 3 (4ha): slight affect by waves and flood
- Area 4 (2ha): not affected by waves and flood but hot weather during dry season.

Project's sites in Cam Ranh Bay – Khanh Hoa

The project sites were selected at My Thanh Village, Cam Thinh Dong commune, Cam Ranh Town, Khanh Hoa province, based on the field trip surveys and the local planning to 2020.

The project sites include 4 fallow shrimp farming areas with total areas of 10ha:
